**REQUEST FOR FINAL ACTION – EVALUATION 2020-15768 – TRANSMISSION AND  
POWER SUPPLY ARC FLASH PROTECTION**

# TRANSMISSION AND POWER SUPPLY ARC FLASH PROTECTION

Evaluation 2020-15768  
August 2, 2021

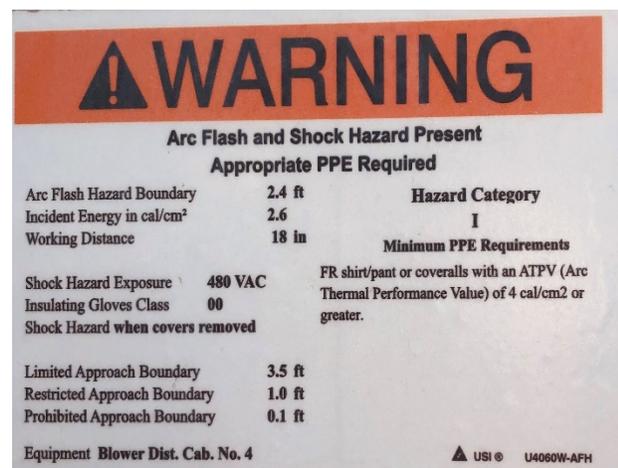
Illustration 1: Arc Flash Warning Label at Hiwassee 500kV substation.

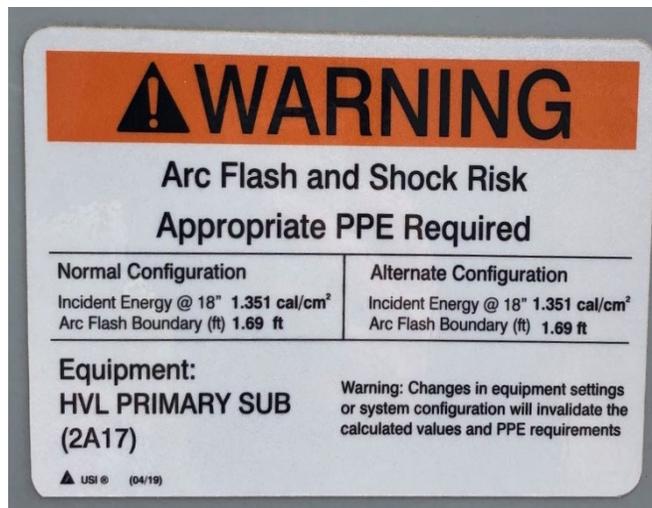
- Four arc flash warning labels at Franklin 500kV had different incident energy information than was provided on the hazard analysis.
- Two arc flash warning labels at Franklin 500kV did not reflect the worst-case incident energy from the hazard calculations.
- Some high-hazard energy equipment was not labeled at Rutherford and Widows Creek 500kV sites.
- Widows Creek warning labels did not include shock hazard or PPE category ratings as shown in Illustration 3.

Illustration 3: Arc Flash Warning Label at Widows Creek 500kV switchyard.

- Verify warning labels are placed on hazardous equipment and meet requirements.

TPS agrees with this recommendation. We are in the process of implementing a plan to evaluate and make legible the arc flash hazard warning labels for known sites with in scope enclosed systems. These warning labels will again be updated, as needed, as hazard analyses are updated.
