Memorandum from the Office of the Inspector General

REQUEST FOR MANAGEMENT DECISION – EVALUATION 2016-15390 – JOHN SEVIER FOSSIL PLANT DEMOLITION PROGRAM

John Sevier Fossil Plant (JSF) is the first in the series of planned plant retirements to enter the demolition phase of the Tennessee Valley Authority's (TVA) Decommissioning, Deactivation, Decontamination, and Demolition (D4) process. In the demolition phase, the plant, associated equipment, facilities, and structures are removed. Demolition also includes creating conditions for proper site drainage and establishing vegetation. TVA contracted with Brandenburg Industrial Service Company¹ (Brandenburg) to perform the demolition at JSF.

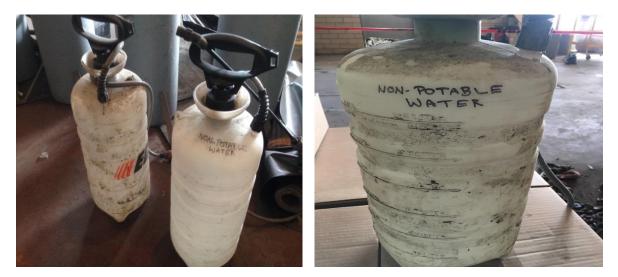
Figure 1: Unlabeled Canister

During our site walk-through on September 16, we noted potential safety hazards that could cause injury or vehicle damage including (1) an unlabeled canister containing non-potable water (Figure 1 on the following page); (2) uncapped fence posts with exposed, sharp corners along a common walkway (Figure 3 on the following page); and (3) corners of a large metal plate were not flush with the ground, with one corner extending up to approximately 1 foot above ground level (Figure 5 on report page 7). Brandenburg agreed these conditions presented potential safety hazards and corrected the conditions by

(1) labeling the non-potable water canister (Figure 2 below), (2) installing protective caps on fence posts we identified (Figure 4 below), and (3) mechanically flattening the metal plate to lessen the likelihood of injury or vehicle damage (Figure 6 on the following page).
